# EPBC Act referral

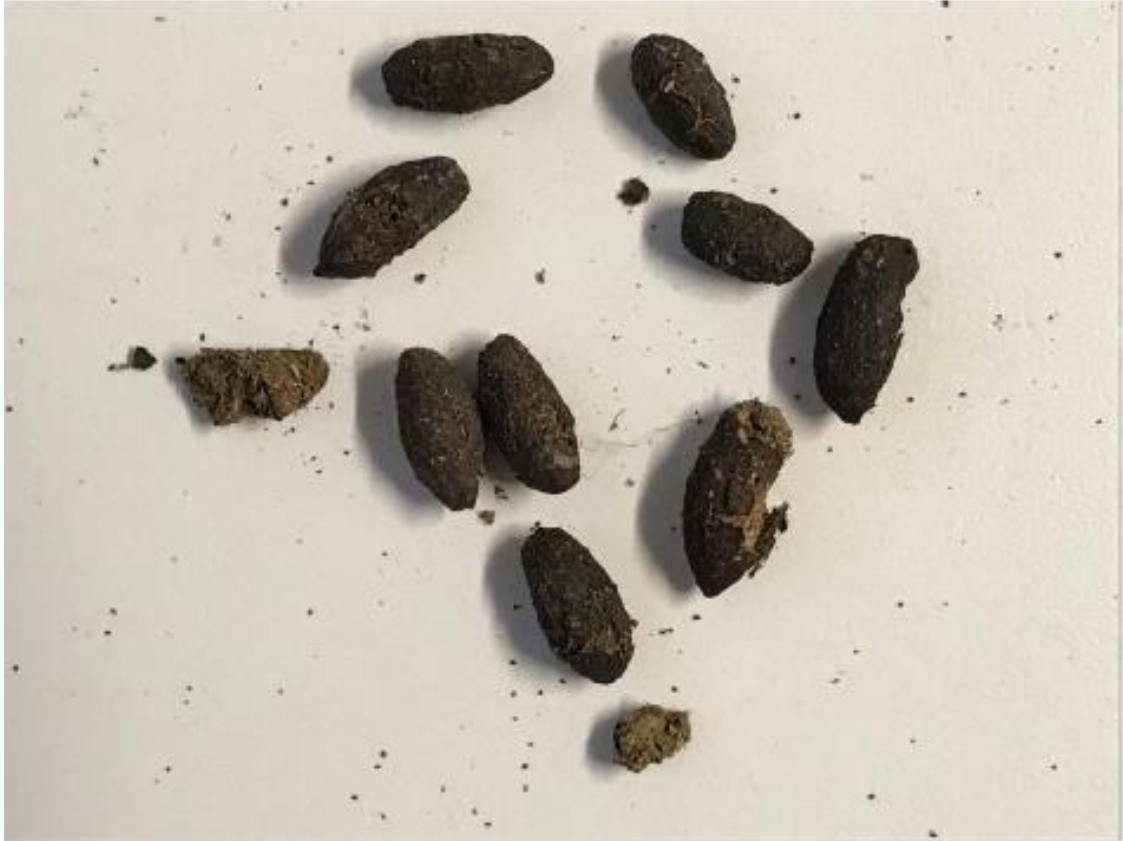
Plate 5-1 Typical Koala Scat Shape Found in the Field

- Preliminary survey and targeted survey - Koala skull (refer to Plate 5-2 and Plate 5-3);
- Targeted survey - Scats age 4 (months old), of similar size and shape (likely from the same Koala) (refer to Plate 5-1);
- BioCondition survey – Evidence of koala skull and scats; and
- Access Corridor Survey – Evidence of presence in form of tree scratches and scats found at three survey locations.

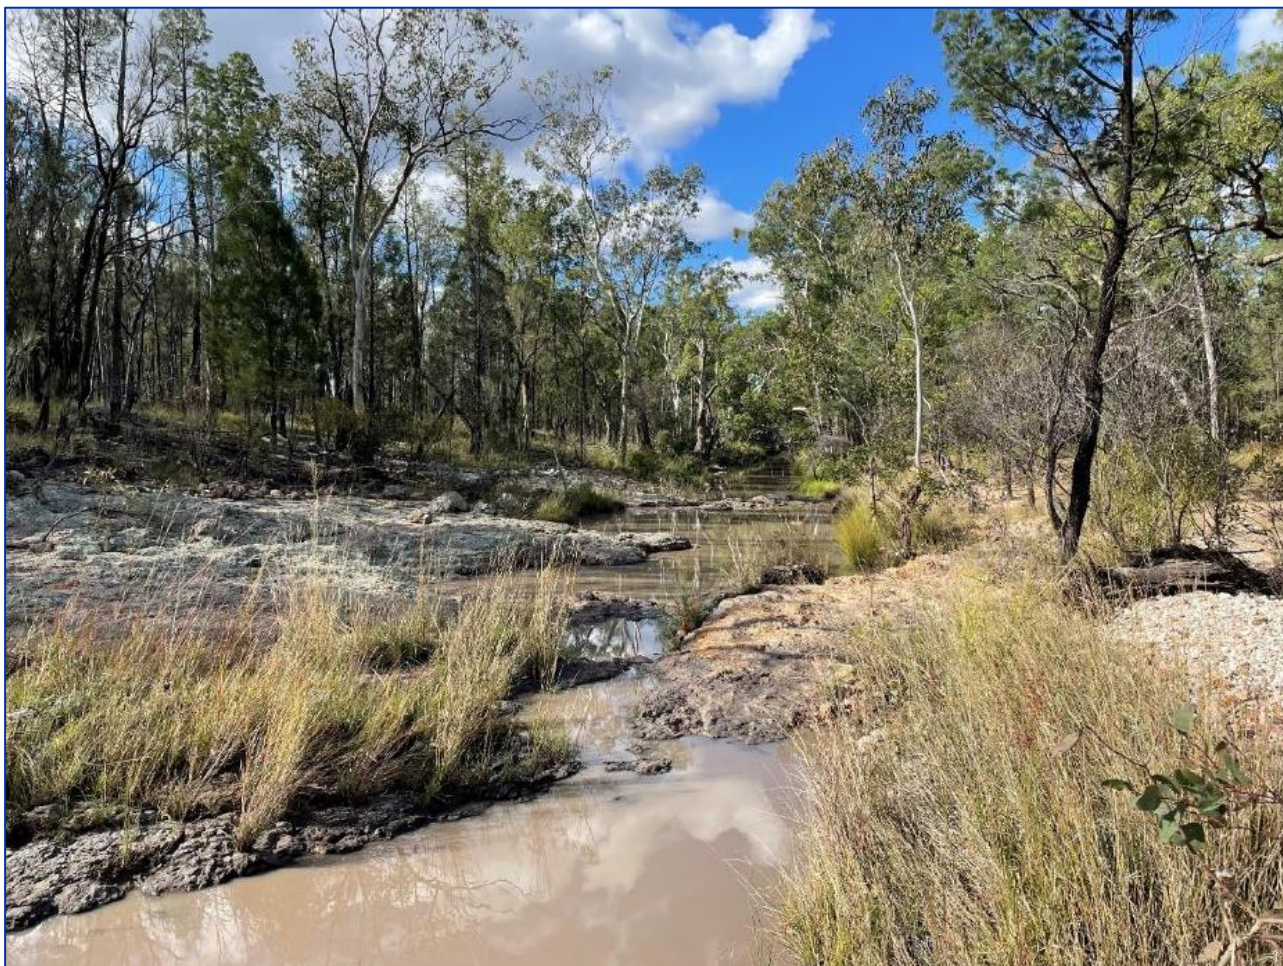
Plate 5-8 Access Corridor Creek

The access corridor intersects a low stream order (2) creek (refer to Figure 5-11). The creek is typically dry for most of the year and only flows during heavy rainfall events. For this reason, the creek is considered not to have permanent flow conditions and exhibits ephemeral flow characteristics. The creek has a discernible low flow/high flow channel as well as high banks. The creek is partly incised into the underlying bedrock and there are semi-permanent waterholes present within the main channel. Plate 5-8, presents a view of this ephemeral creek, noting the recent rainfall event has filled the waterholes with a low trickle flow still occurring. Refer to **Appendix I** for the field assessment sheets for this water feature. The creek is mapped as an Amber (Moderate) waterway under the Queensland Waterways for Waterway Barrier Works, as defined under the *Fisheries Act 1994*. The field determination of the creek is as a defined watercourse under the *Water Act 2000*.

The access corridor intersects a low stream order (2) creek. The creek is typically dry for most of the year and only flows during heavy rainfall events. For this reason, the creek is considered not to have permanent flow conditions and exhibits ephemeral flow characteristics. The creek has a discernible low flow/high flow channel as well as high banks. The creek is partly incised into the underlying bedrock and there are semi-permanent waterholes present within the main channel. The creek is mapped as an Amber (Moderate) waterway under the Queensland Waterways for Waterway Barrier Works, as defined under the Fisheries Act 1994. The field determination of the creek is as a defined watercourse under the Water Act 2000.

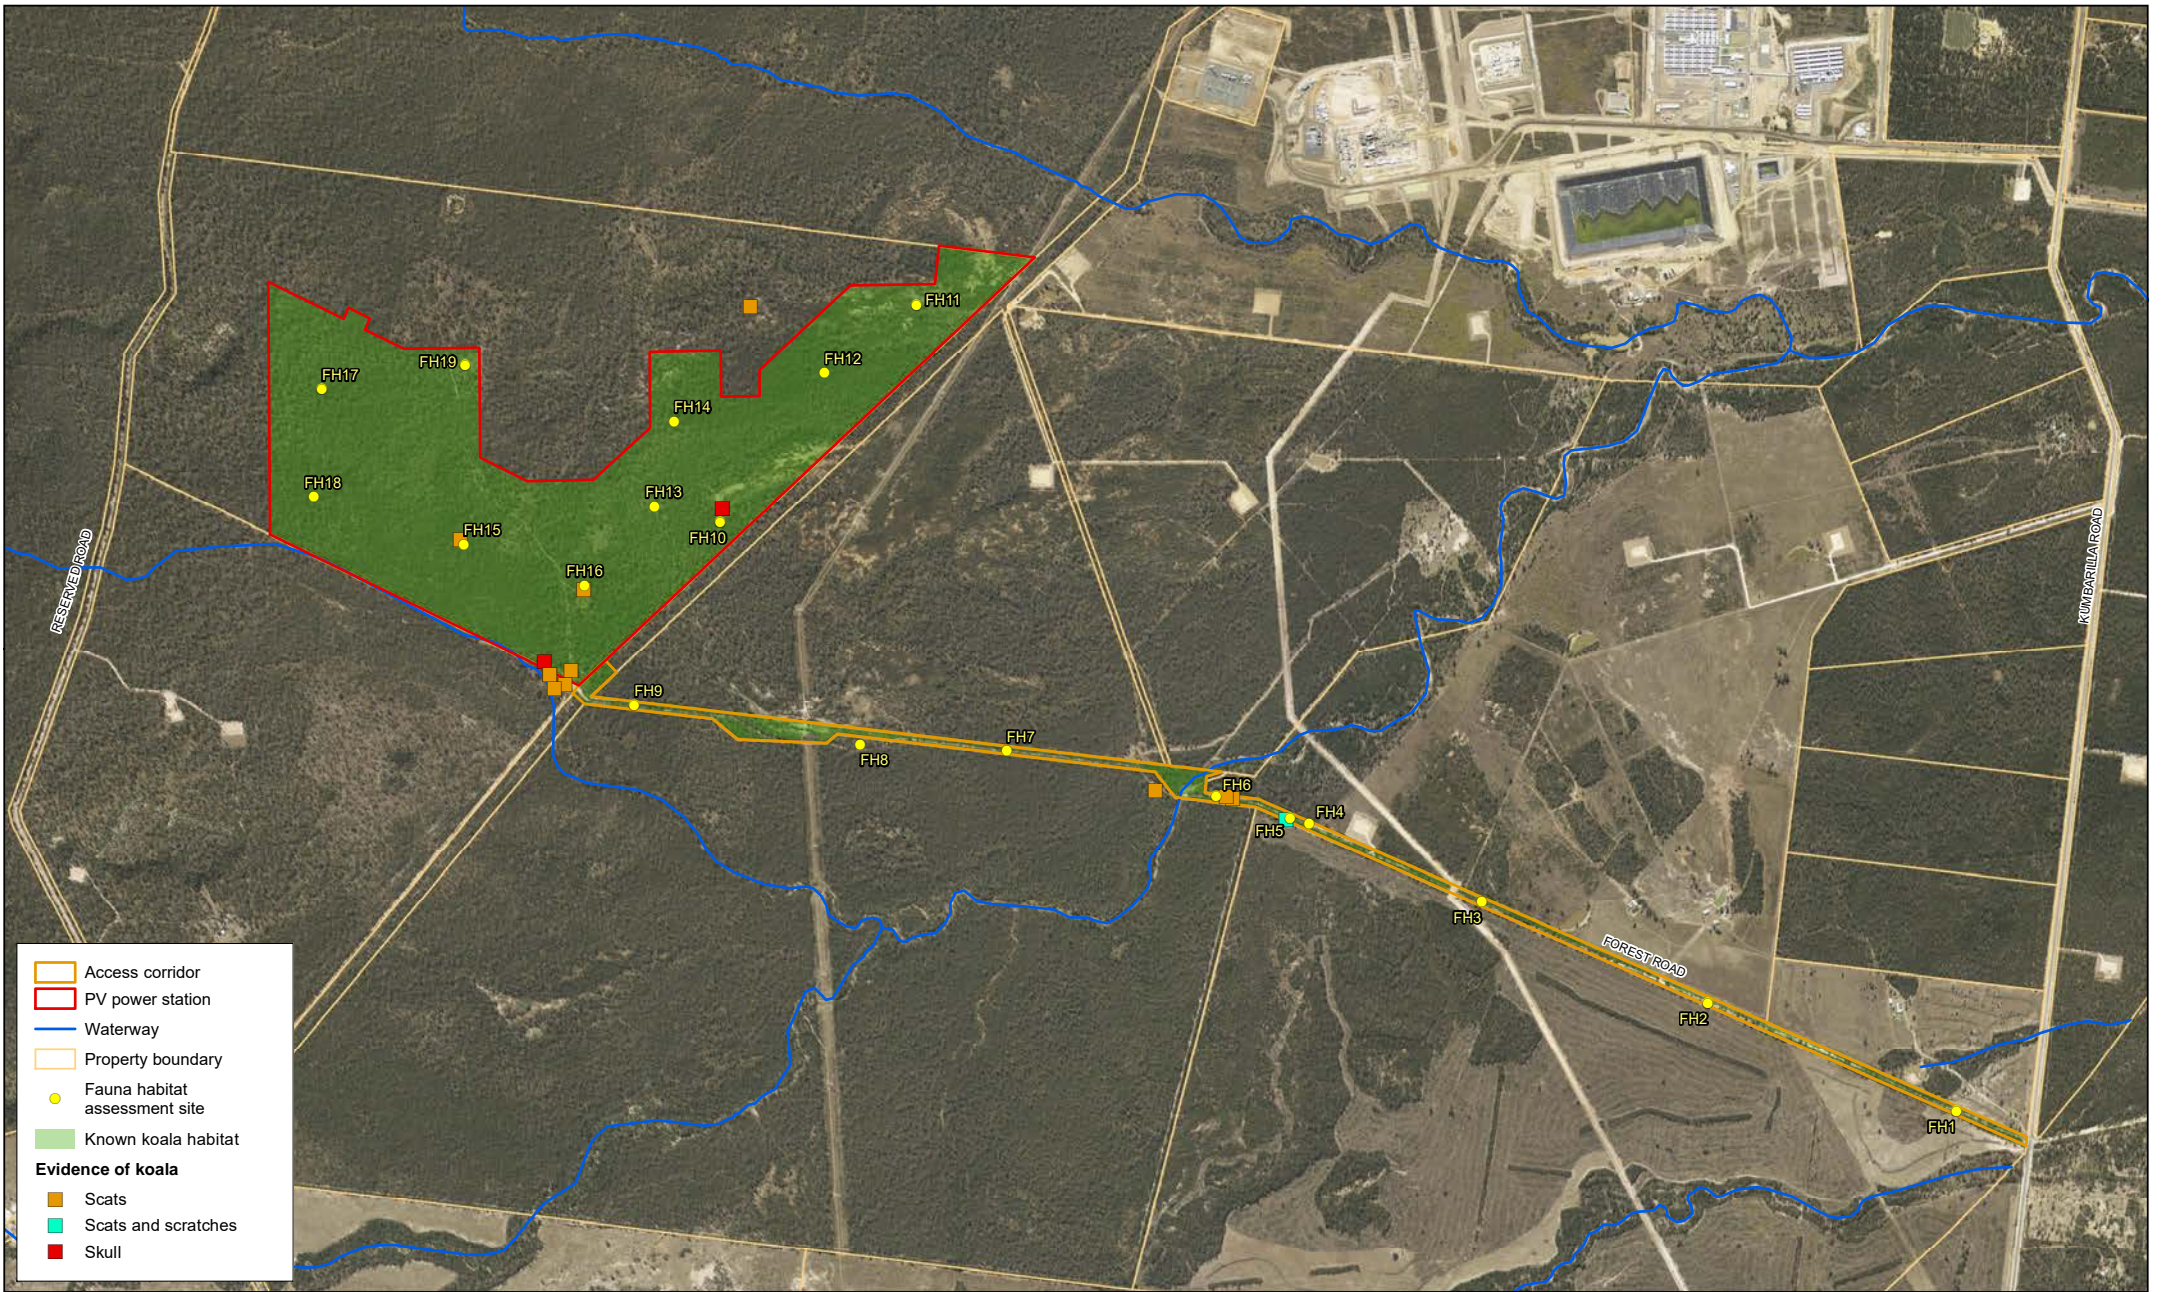
Evidence of Koala was identified in the Project area during field surveys, through the discovery of Koala scats and a Koala skull within the PV power station component of the Project area. The low density, condition and sizes of the Koala scats suggest a single Koala has been present within the site boundary several months prior to the survey. Evidence of Koala habitation in the form of scratches and scats was also located at three sites within the access corridor.

Access corridor  
 PV power station  
 Waterway  
 Property boundary  
● Fauna habitat assessment site  
 Known koala habitat  
**Evidence of koala**  
 Scats  
 Scats and scratches  
 Skull

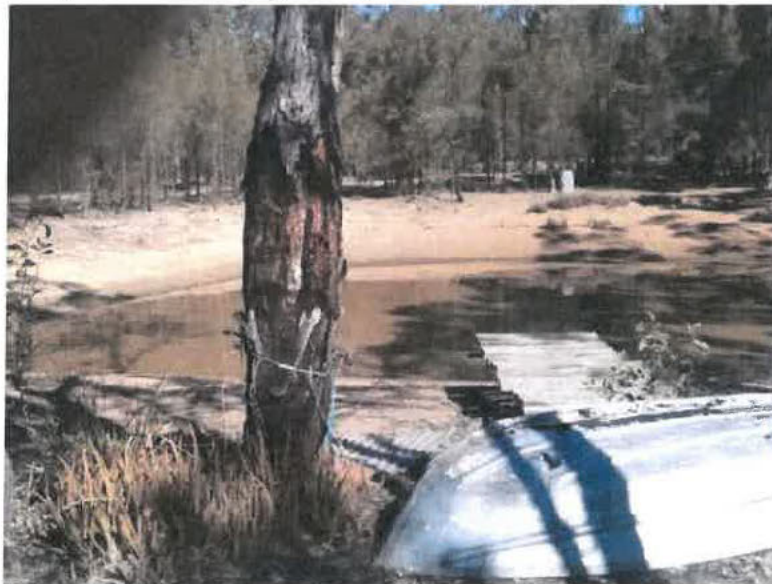
Figure 1: Existing On site Dam

Groundwater is currently captured in an existing manually-excavated dam (see below):

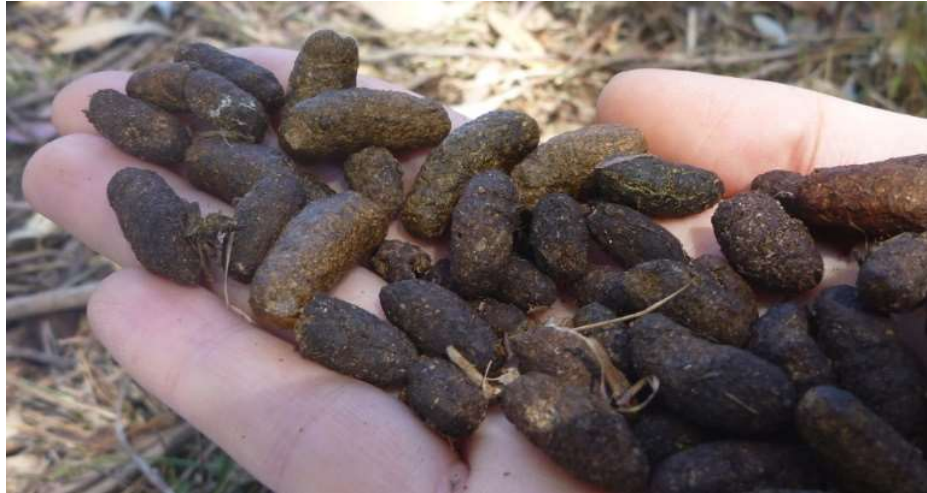
Figure 2 Typical koala scat shape found in the field

- symmetrical and bullet-shaped (not jelly-bean shaped);
- generally about 1.5 cm long by 0.5 cm wide (adult koala scat size);
- even-sized and especially fine particles;
- absence of insect parts (koalas do not eat insects); and
- very compact.

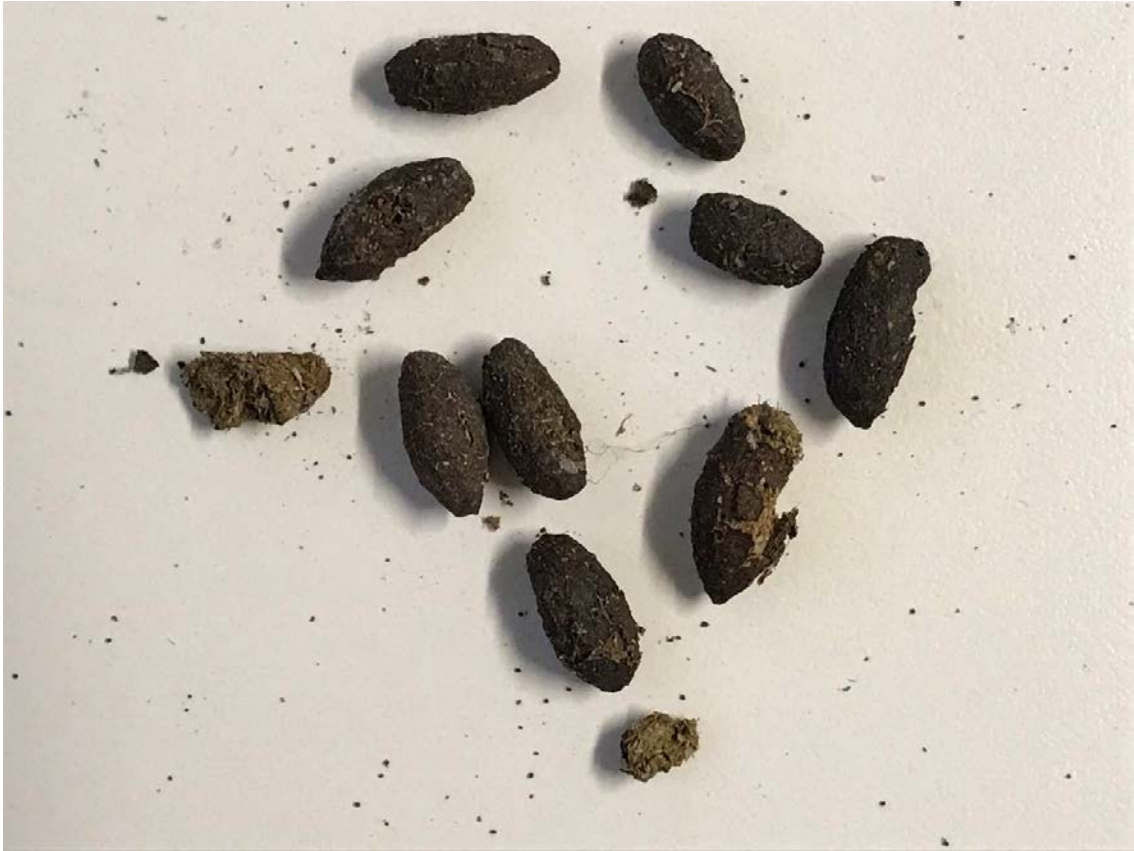
Figure 5 Koala scats collected on site

- scats age 4 (months old), of similar size and shape (likely from the same koala) at 285539 / 6985459 (Figure 5),
- koala skull at 285340 / 6984586 (Figure 6).

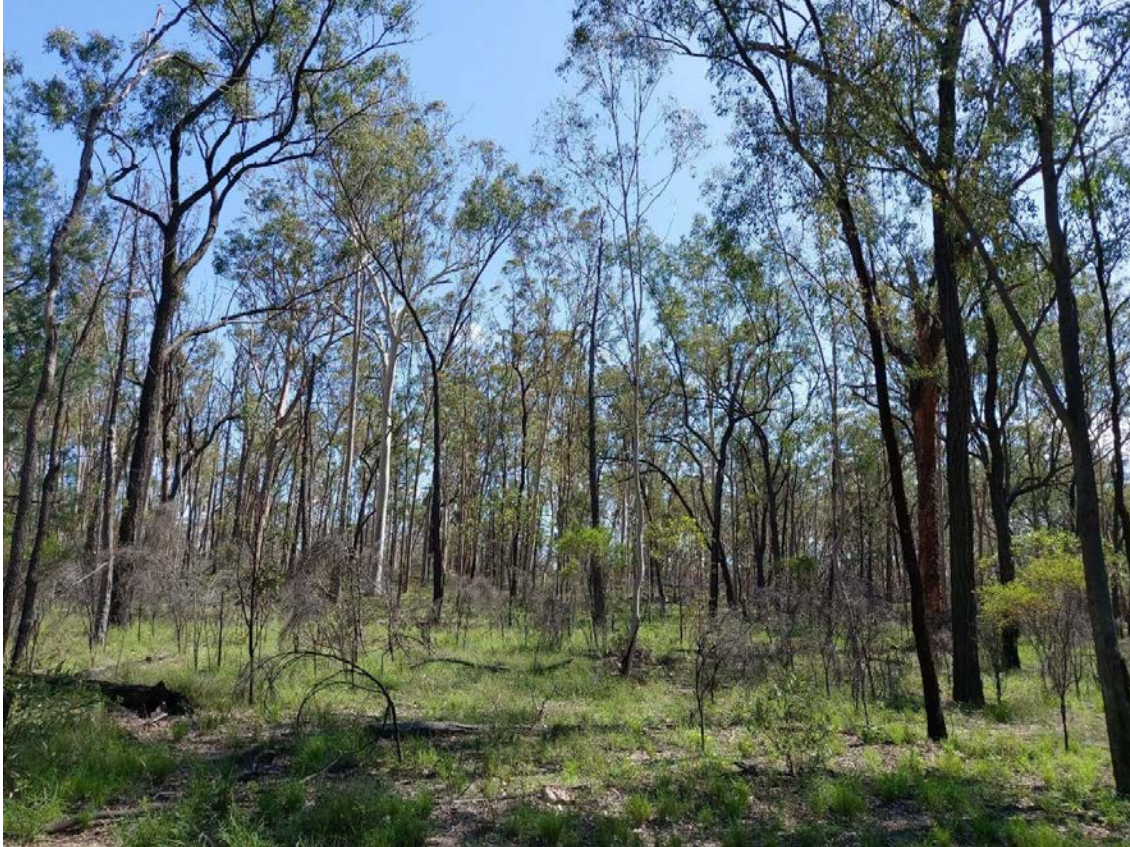
Figure 7 Example of the vegetation at the survey area

From the low density of koala scats, it is likely that koalas have been in the area surveyed several months prior to the survey. Note that the area was only surveyed on one occasion; therefore, the presence / absence results presented here provide a snapshot of the population during this period and in the recent months only.

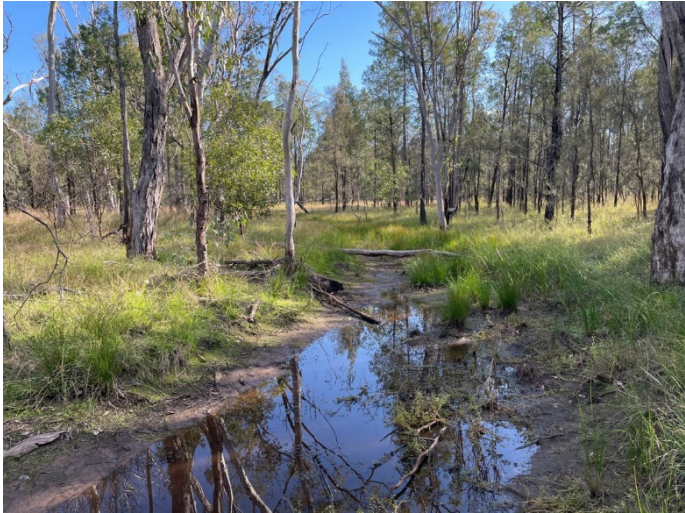
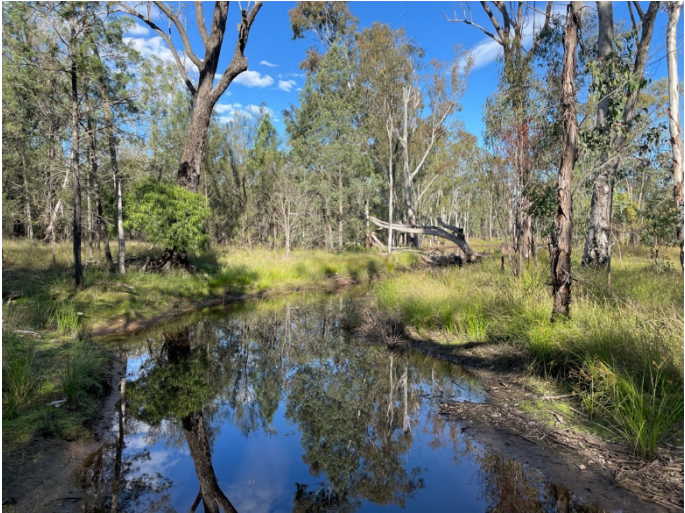
Assessor/Field Staff: Bruce McLennan	Date: 26/5/21
Site: Unnamed gully SO1	Survey: Watercourse
Landform: stream	Coordinates: -27.249548, 150.825705
Weather Condition: Fine and mild	Type of Work being carried out: Waterway assessment
Site Access: Forest Road	Comments: the site is in the original channel with dam embankment approximately 100 m downstream
Waterway Features	
Condition: good	Recent Rainfall: 29 mm in previous two weeks
Waterway type: natural	Flow Condition: not flowing
Likely Flow Permanence: seasonal/ephemeral	Habitat Types in 100 m Reach, centred on site: Eucalyptus tereticornis/Eucalyptus crebra woodland
Artificial or Natural Waterway (e.g. channelization): natural	Well Defined Bed and Banks (Y/N): yes
Bank Soil/Sediment Type: clay, sand	Slope Along Reach: low 11-30°
Bed Sediment Composition (%): - Bedrock: - Boulder (>256 mm): - Cobble (64-256 mm): - Pebble (4-64 mm): - Gravel (2-4 mm): - Sand (0.05-2 mm): - Silt/Clay (<0.05 mm): 100	Bankfull Height: 1m

Bankfull Width: 10m
Maximum Water Depth Observed: 0.3m	Low-flow Channel Width: 3m
Bank Slope: Low 11-30°	Continuous Bank/Bed Up/Downstream: continuous
Broken/Continuous section of Bank/Bed: Continuous	Suggested Definition: watercourse
Channels Upstream/Downstream: continuous	Bank/Bed Erosion Extent and Type: minimal, gully
Connectivity to other Waterbodies: feeds into Moramby Creek, to Wilkie Creek which feeds Condamine River	Fish Habitat Upstream: Fringing non-woody, fringing woody, shallow (<0.5m) pool, earth bank, sandy bank
Freshwater or tidally Influenced: freshwater	Fish Habitat Downstream: Fringing non-woody, fringing woody, shallow (<0.5m) pool, earth bank, sandy bank, detritus 1-10%, sticks 1-10%, branches 1-10%, logs 1-10%
Potential for Fish Habitat at Site: Ephemeral watercourse with earth dam approx 100 m downstream. Will be dry as dam contracts. No detritus or woody debris.	Mapped Risk of Impact to Fish Passage: Low

**Comments:**  
**Suggested Definition: Watercourse**

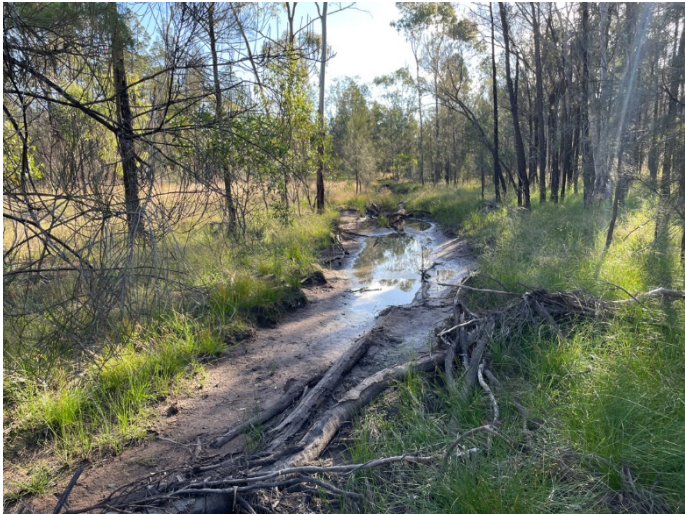
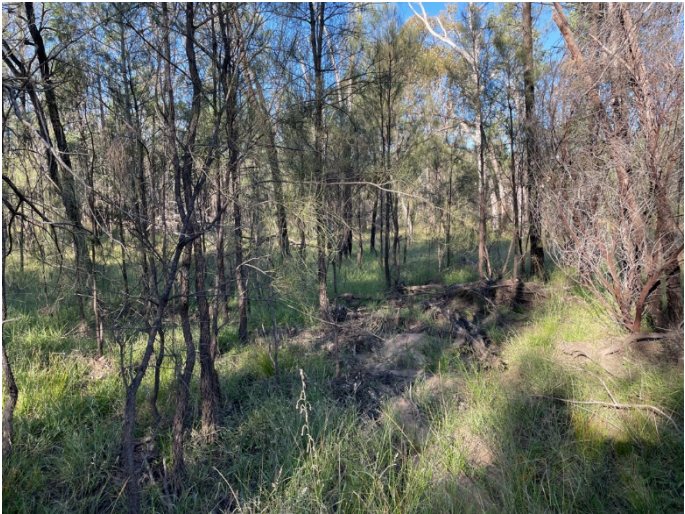
Assessor/Field Staff: Bruce McLennan	Date: 26/5/21
Site: Unnamed gully SO1	Survey: Watercourse
Landform: stream	Coordinates: -27.2487, 150.8236
Weather Condition: Fine and mild	Type of Work being carried out: Waterway assessment
Site Access: Forest Road	Comments: meandering gully
<b>Waterway Features</b>	
Condition: good	Recent Rainfall: 29 mm in previous two weeks
Waterway type: natural	Flow Condition: not flowing
Likely Flow Permanence: ephemeral	Habitat Types in 100 m Reach, centred on site: Eucalyptus crebra/Allocasuarina luehmannii woodland
Artificial or Natural Waterway (e.g. channelization): natural	Well Defined Bed and Banks (Y/N): no
Bank Soil/Sediment Type: clay/sand	Slope Along Reach: flat 0-10°
Bed Sediment Composition (%): - Bedrock: - Boulder (>256 mm): - Cobble (64-256 mm): - Pebble (4-64 mm): - Gravel (2-4 mm): - Sand (0.05-2 mm): - Silt/Clay (<0.05 mm): 100	Bankfull Height: NA
	Bankfull Width: NA

Maximum Water Depth Observed: 0.3m	Low-flow Channel Width: 3m
Bank Slope: poorly defined bank	Continuous Bank/Bed Up/Downstream: continuous
Broken/Continuous section of Bank/Bed: broken	Suggested Definition: watercourse
Channels Upstream/Downstream: broken	Bank/Bed Erosion Extent and Type: minor, gully
Connectivity to other Waterbodies: feeds into Moramby Creek, to Wilkie Creek which feeds Condamine River	Fish Habitat Upstream: Fringing non-woody, fringing woody, shallow (<0.3m) pool, earth bank, sandy bank
Freshwater or tidally influenced: freshwater	Fish Habitat Downstream: nonexistent, overland flow through woodland till banks reform
Potential for Fish Habitat at Site: Minimal fish habitat at site, waterhole upstream is free draining and very short term.	Mapped Risk of Impact to Fish Passage: Low
Wetland Indicator Plants: Fringing of sedges and rushes.	Fish Species Opportunistically Detected: none detected

**Comments:**  
**Suggested Definition: Natural drainage**

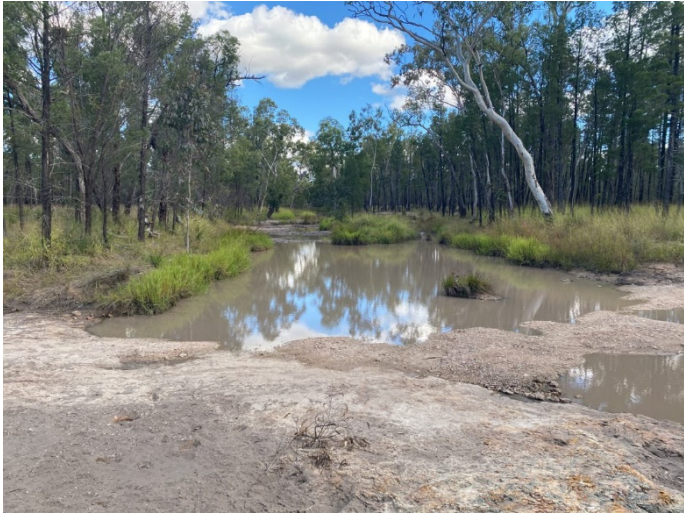
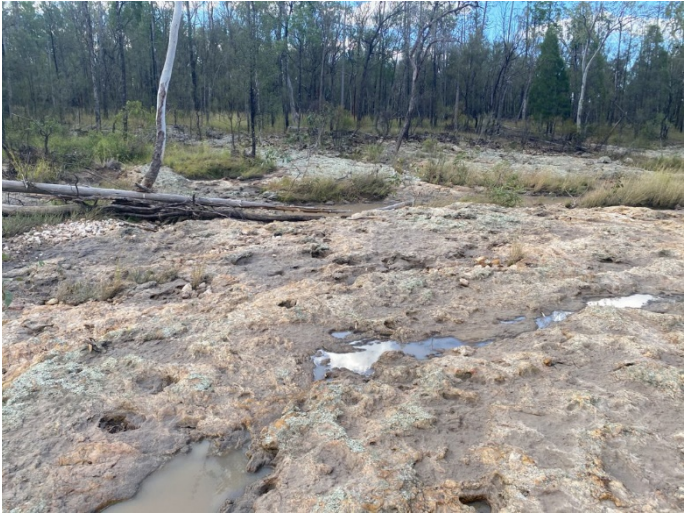
Project: K-REP Waterway Assessment	
Assessor/Field Staff: Ben Nottidge	Date: 24/5/21
Site: Moramby Creek SO2	Survey: Watercourse
Landform: stream	Coordinates: -27.2541, 150.8493
Weather Condition: Fine and mild	Type of Work being carried out: Waterway assessment
Site Access: Forest Road crossing	Comments:
Waterway Features	
Condition: average	Recent Rainfall: 29 mm in previous two weeks
Waterway type: natural	Flow Condition: trickle
Likely Flow Permanence: seasonal	Habitat Types in 100 m Reach, centred on site: open to closed Callitris/Eucalypt forest
Artificial or Natural Waterway (e.g. channelization): natural	Well Defined Bed and Banks (Y/N): yes
Bank Soil/Sediment Type: silt/loam	Slope Along Reach: flat <10°
<b>Bed Sediment Composition (%):</b> - Bedrock: 90%                      - Gravel (2-4 mm): 5% - Boulder (>256 mm):            - Sand (0.05-2 mm): 5% - Cobble (64-256 mm):            - Silt/Clay (<0.05 mm): - Pebble (4-64 mm):	Bankfull Height: 0.6m

Bankfull Width: 12m
Maximum Water Depth Observed: 0.6m	Low-flow Channel Width: 3m
Bank Slope: Low 11-30°	Continuous Bank/Bed Up/Downstream: continuous
Broken/Continuous section of Bank/Bed: Continuous	Suggested Definition: watercourse
Channels Upstream/Downstream: continuous	Bank/Bed Erosion Extent and Type: minimal gully
Connectivity to other Waterbodies: feeds into Wilkie Creek which feeds Condamine River	Fish Habitat Upstream: Fringing non-woody, fringing woody, shallow (<0.5m) pool, undercut bank, rocky banks, earth bank
Freshwater or tidally Influenced: freshwater	Fish Habitat Downstream: Fringing non-woody, fringing woody, shallow (<0.5m) pool, undercut bank, 1-10% detritus, 1-10% sticks, earth banks, rocky banks
Potential for Fish Habitat at Site: occasional waterholes that may contain fish for full season, fringing non-woody, fringing woody, shallow (<0.5m) pool, undercut bank, 1-10% sticks, earth banks, rocky banks	Mapped Risk of Impact to Fish Passage: Moderate (Amber)

Comments:  
Suggested Definition: Watercourse

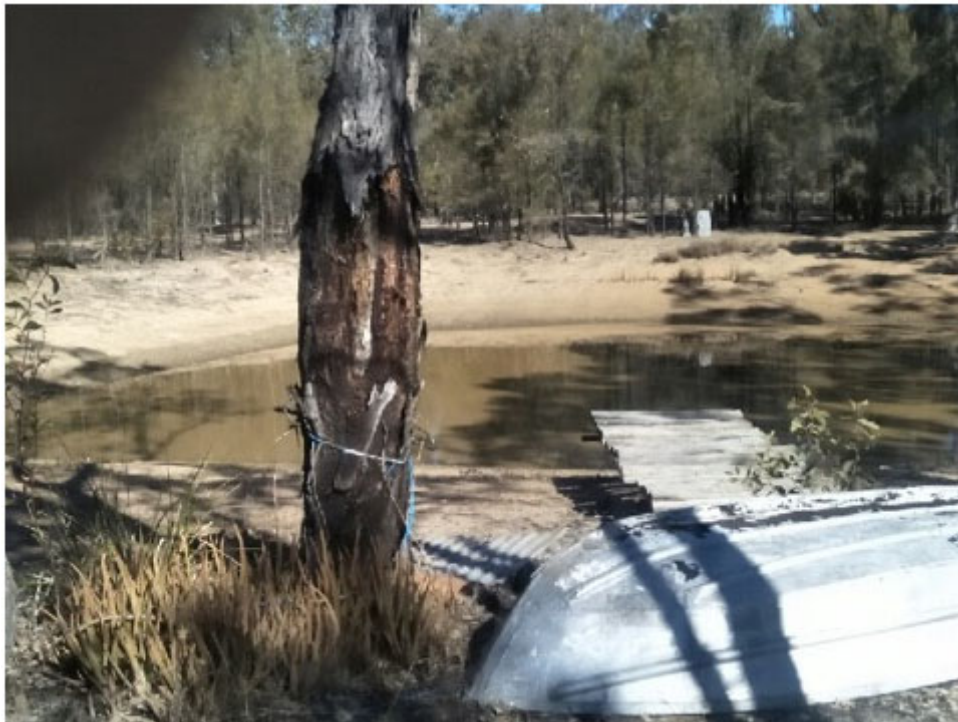
Figure 1: Existing On site Dam

Groundwater is currently captured in an existing manually-excavated dam (see below):

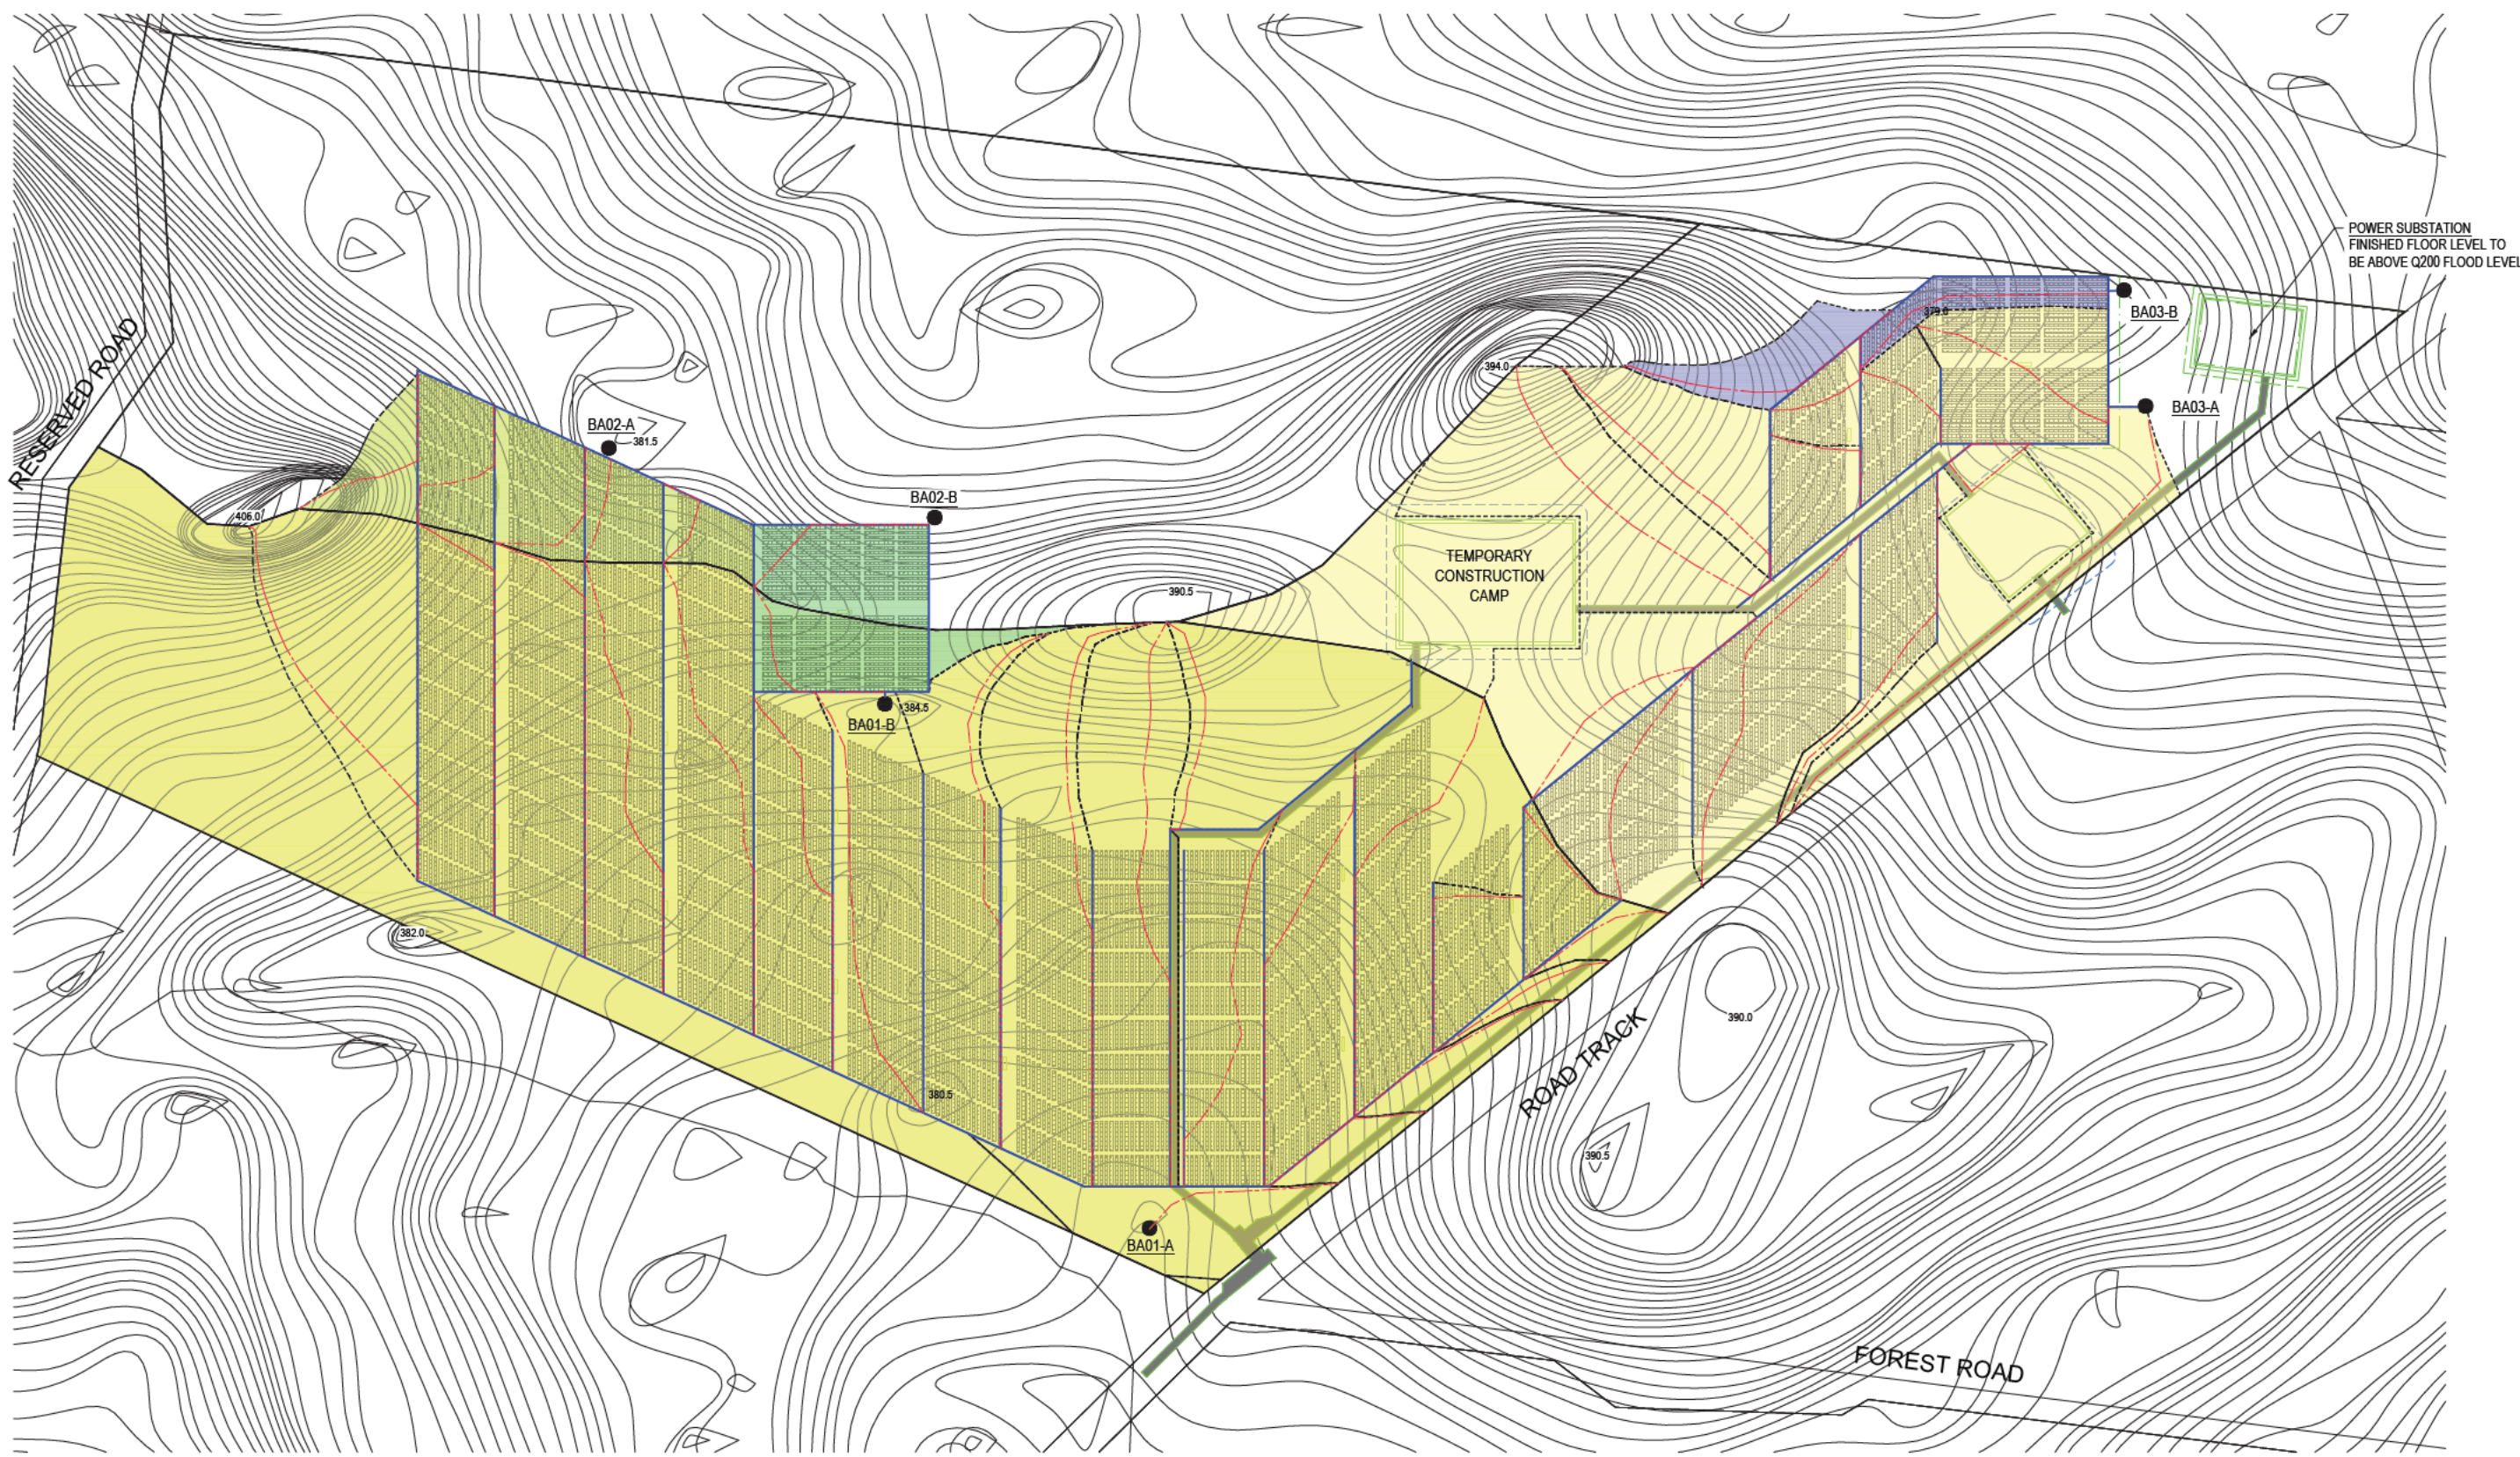
## Appendix B      Drainage Layout Plan

The open channel and pipe network will divert stormwater to central stormwater detention basins at 6 locations across the proposed site. Basin storage will be sized to maintain outflows at pre-development flow rates and will be sized to accommodate the 10% AEP event. Outflows from the basin will be via infiltration, evaporation and outflow at pre-development flow rates.
